**Virginia Commonwealth University
Transportation Safety Training Center
Crash Investigation Team**

Report Number 191 - October 2003

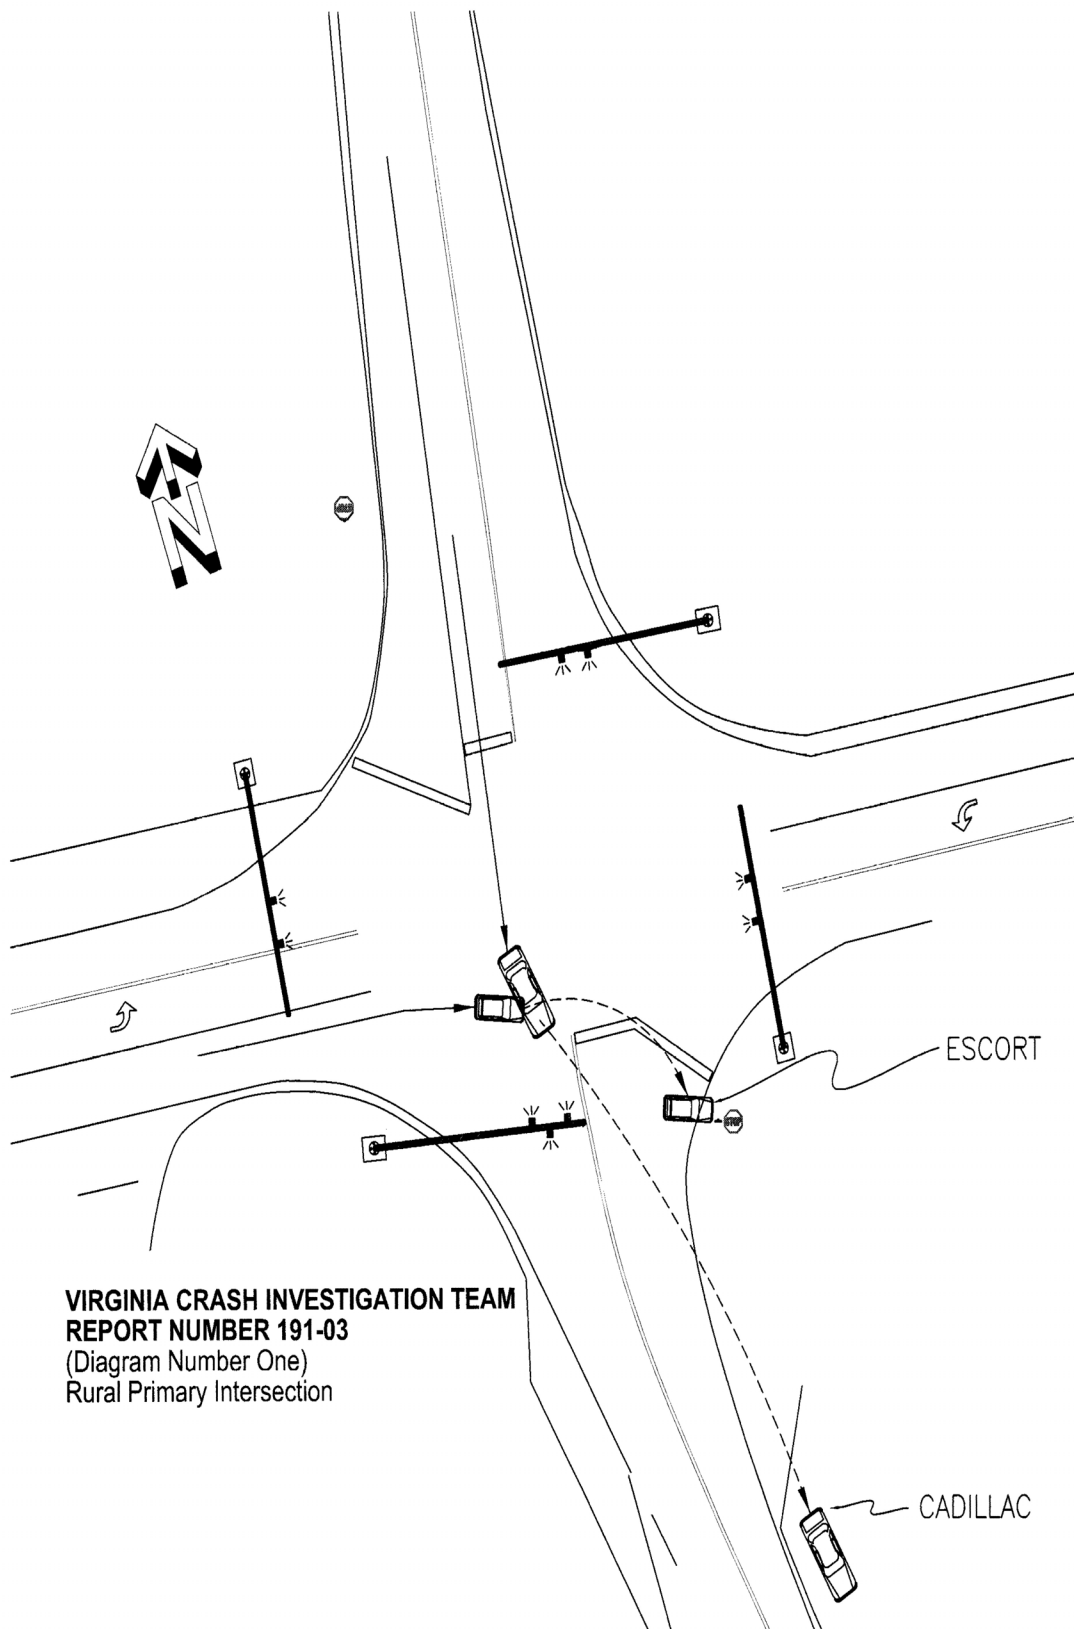
Significant Points: Driver unfamiliarity with roadway and intersection; driver not suspecting a stop situation; older driver characteristics; complex and cluttered intersection with a history of multiple crash involvement and subsequent sign/markings changes; physical evidence interpretation and eyewitness statements compared to the Cadillac's Event Data Recorder.

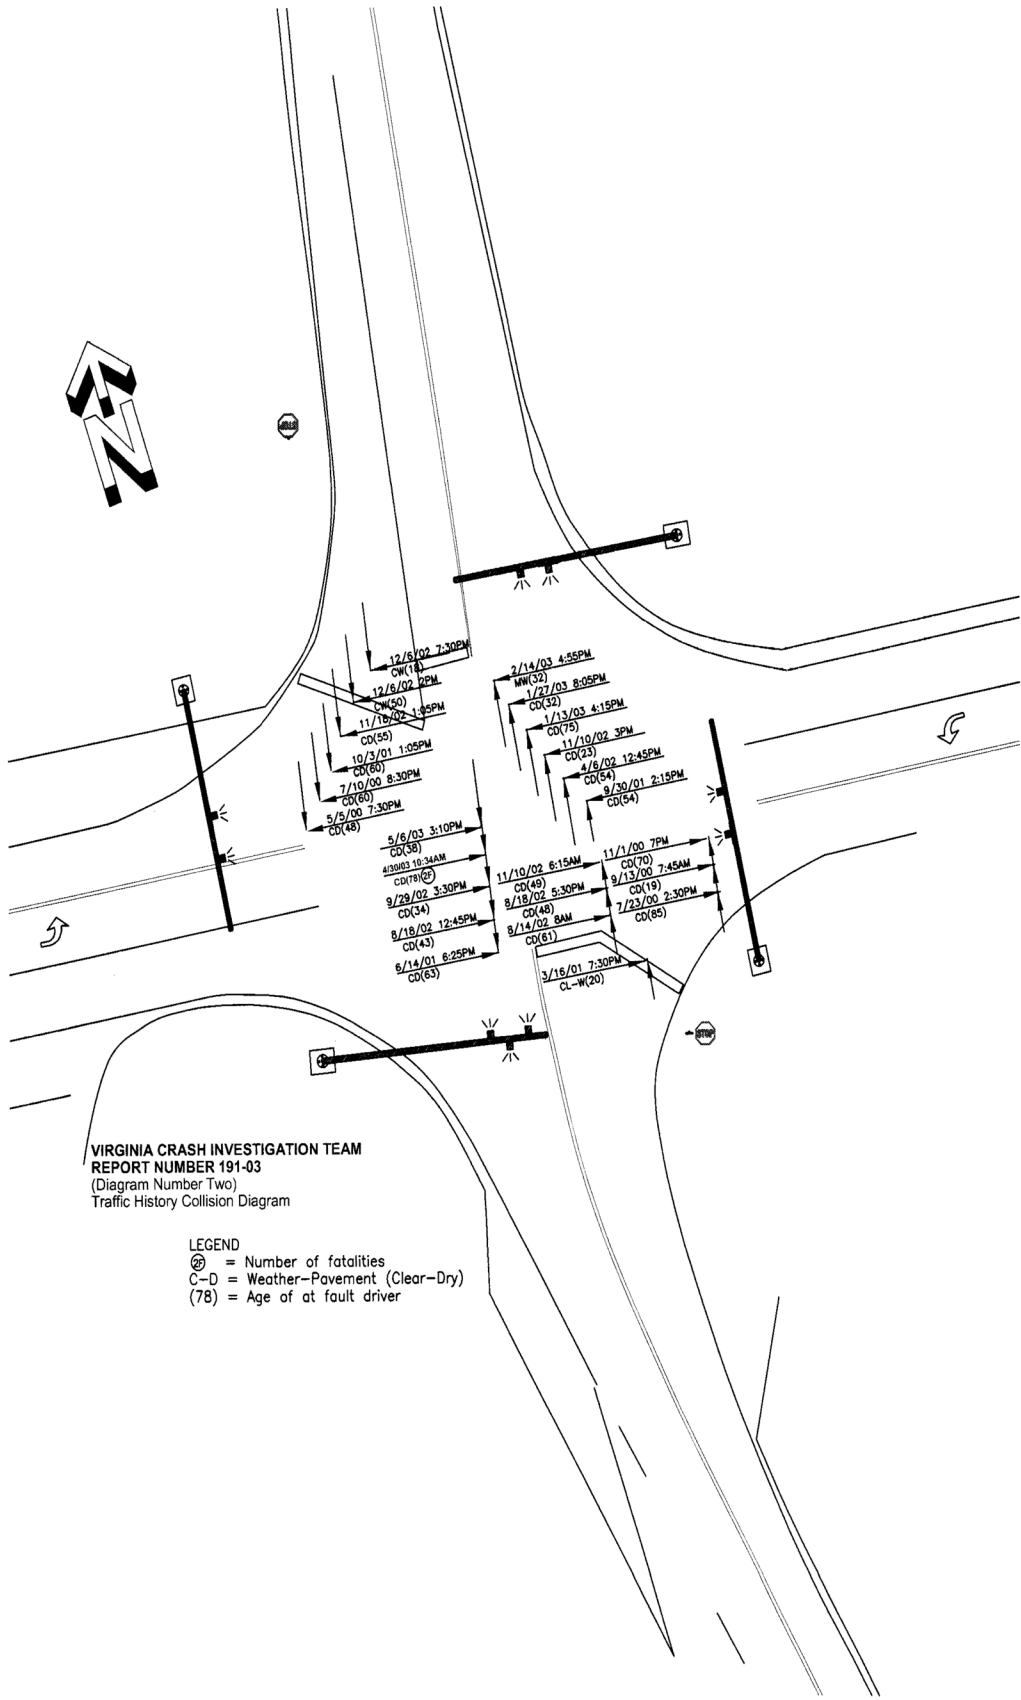
VIRGINIA CRASH INVESTIGATION TEAM
 REPORT NUMBER 191-03
 (Diagram Number Two)
 Traffic History Collision Diagram

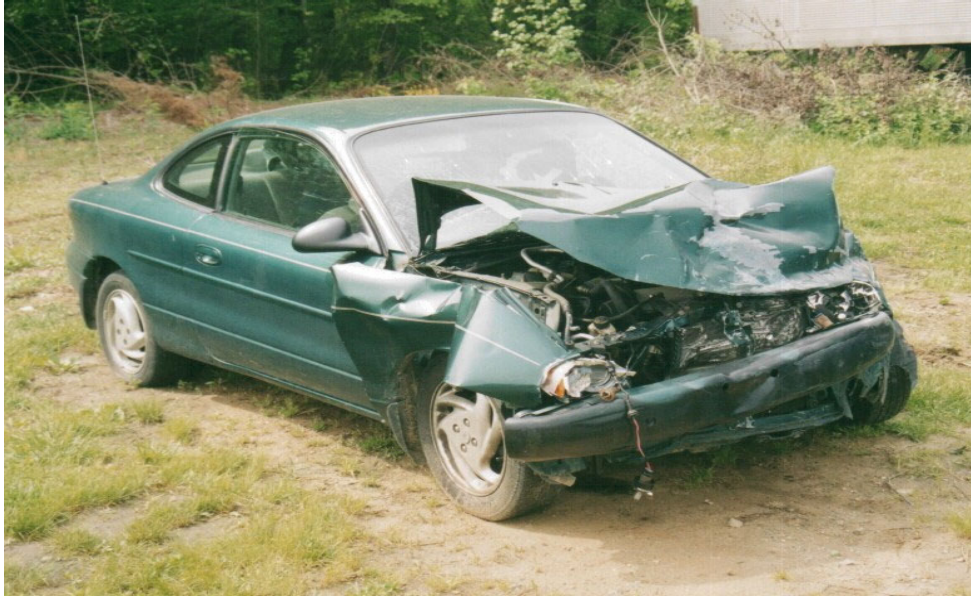
Photo #1- Damage to the 1998 Ford Escort ZX2 caused from colliding with the Cadillac. Maximum static crush sustained to the Ford's front was measured at 20 inches. Momentum analysis indicated that at impact the Ford was traveling at least 49 mph and the Cadillac at 37 mph.

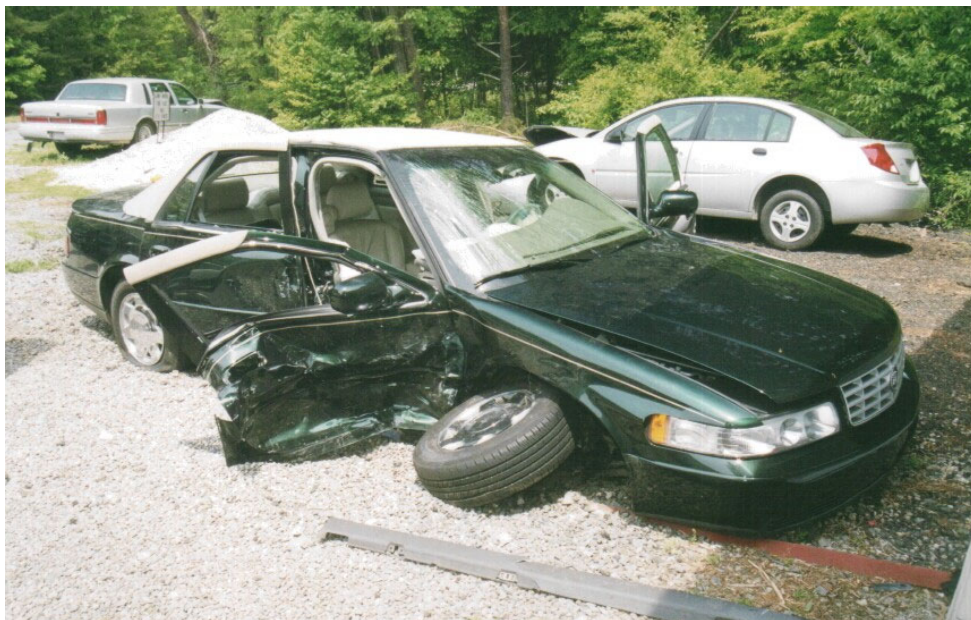
Photo #2- Damage to the 2000 Cadillac Seville SLS from impact with the Ford Escort. Maximum deformation was measured on the right side at 18 inches. The EDR recorded the speed of the Cadillac at 44-39 mph before the airbag triggering system activated (AE).

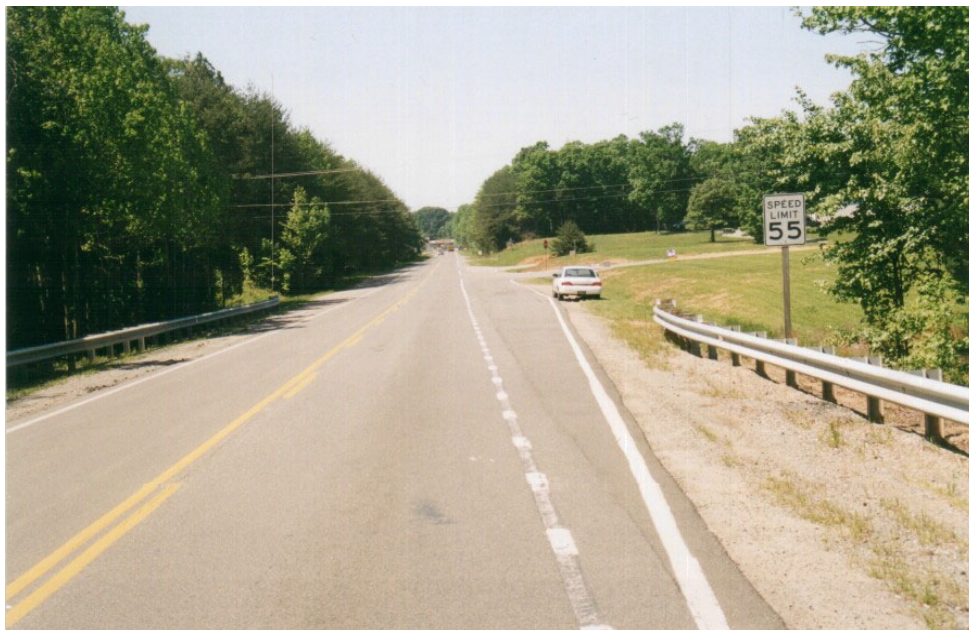
Photo #3- View looking south, the direction the Cadillac driver was traveling, taken about .6 miles before the intersection. This location is about 500 feet after the Cadillac driver exited the interstate. Note the 55mph speed limit sign, and the long/ straight, rural nature of the roadway, and the gas station appearing to be directly in the line of travel.
